Sub-Slab Depressurization System Construction Completion Report

Former General Instrument Corporation Site
Hicksville, New York

May 9, 2017

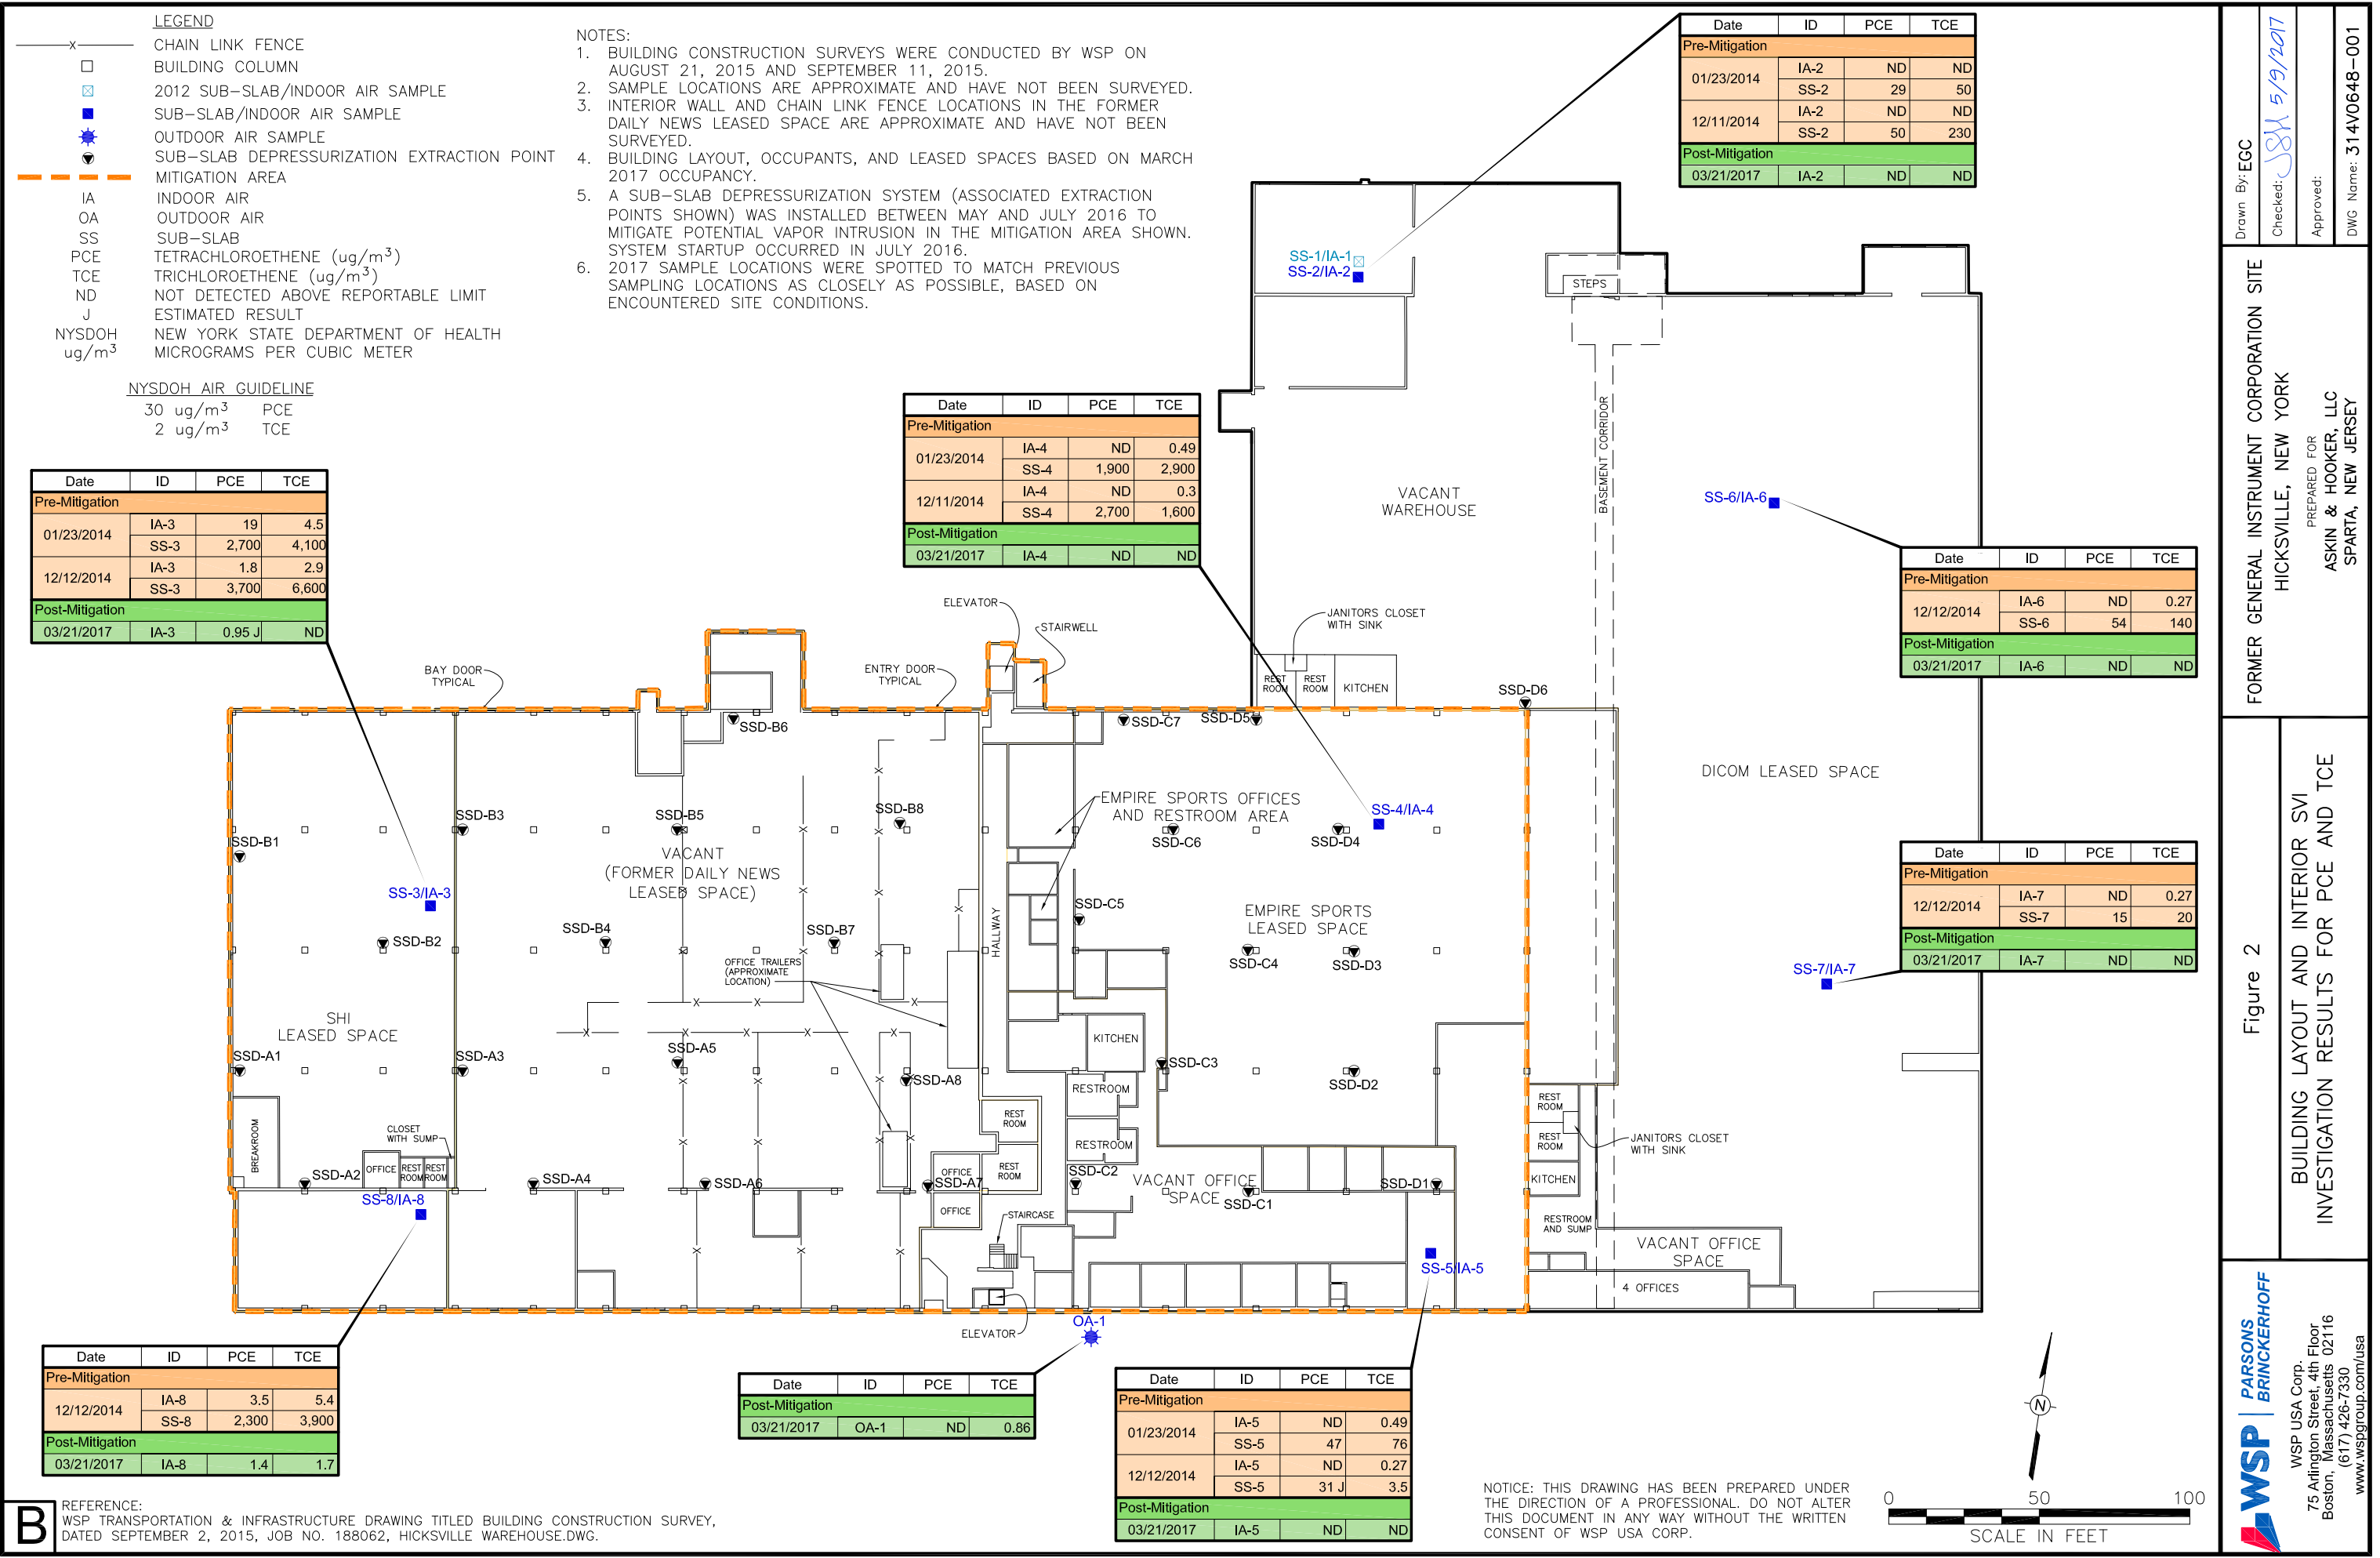
Figure 2 – Building Layout and Interior SVI Investigation Results for PCE and TCE

The building layout presented in Figure 2 incorporates the findings of various building inspections conducted at the site since 2013, and includes active tenants at the time of post-mitigation indoor air sampling in March 2017.

At the time of system installation, three tenants occupied the SVI mitigation area shown on Figure 2. Sid Harvey Industries (SHI), a heating, ventilation, and air conditioning (HVAC) equipment wholesaler, occupied space in the western part of the 1960 original building, including a storefront in the southern portion of the space. The storefront was used for equipment sales, and the northern space was used for receiving and storing HVAC supplies. The equipment sales area was the only space that is continuously occupied by employees. The Daily News occupied the eastern part of the original 1960 building and utilized the space for temporary newspaper storage and distribution. Empire Sports occupied the western portion of the 1967 two-story addition and utilized the warehouse space on the first floor for receiving, storage, and distribution of footwear. The first-floor office area in the southern portion of the 1967 addition, the eastern portion of the 1967 addition, and the 1968 addition were vacant at the time of the SSD installation.

The former GIC site is located at 600 West John Street, northeast of the intersection of West John Street and Cantiague Rock Road in Hicksville, New York (Figure 1). The 11.5-acre site is located in a light industrial section of Hicksville and was developed in 1960 for General Transistor, who was subsequently acquired by GIC. GIC used the facility, including two one-story buildings and one two-story building, for the research, design, and manufacture of semiconductors, radar systems, and electronic equipment until operations ceased in 1994. 600 West John LLC, an unaffiliated company, currently owns the property and leases the buildings to industrial and commercial tenants. Figure 2 presents the facility layout.
